Popes Hill LRD, Popes Road, Blackpool, Cork

Site-Specific Flood Risk Assessment

244132-PUNCH-XX-XX-RP-0013

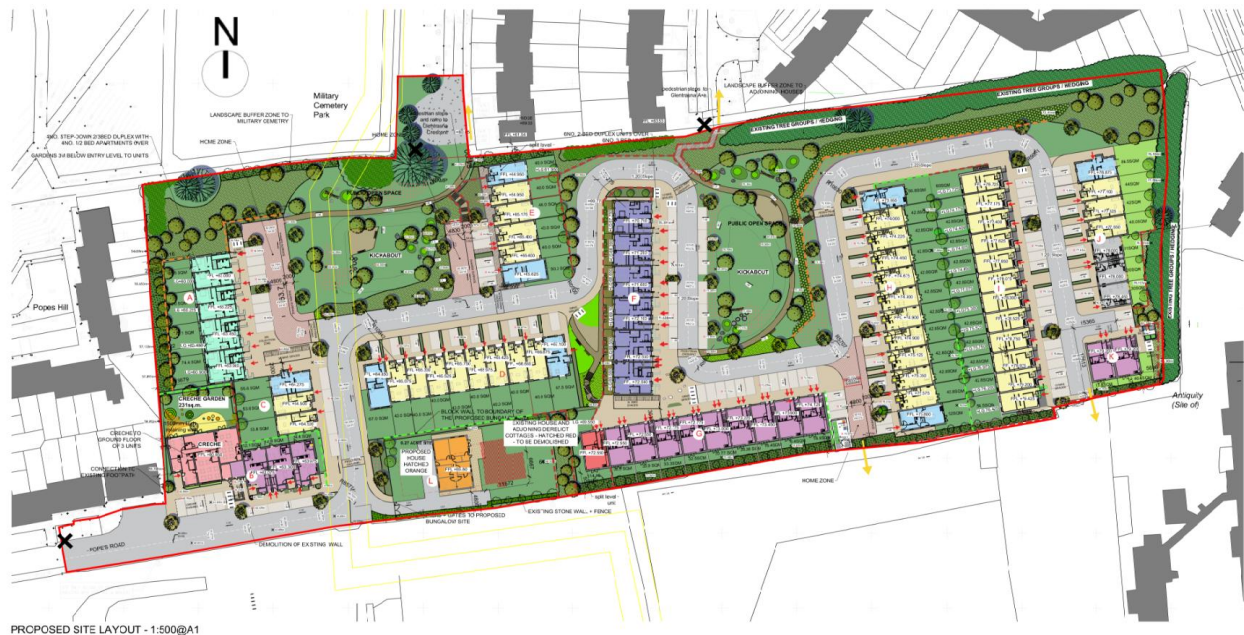
Figure 1-2: Proposed Site Layout

The proposed site layout can be seen in Figure 1-2 of this document.

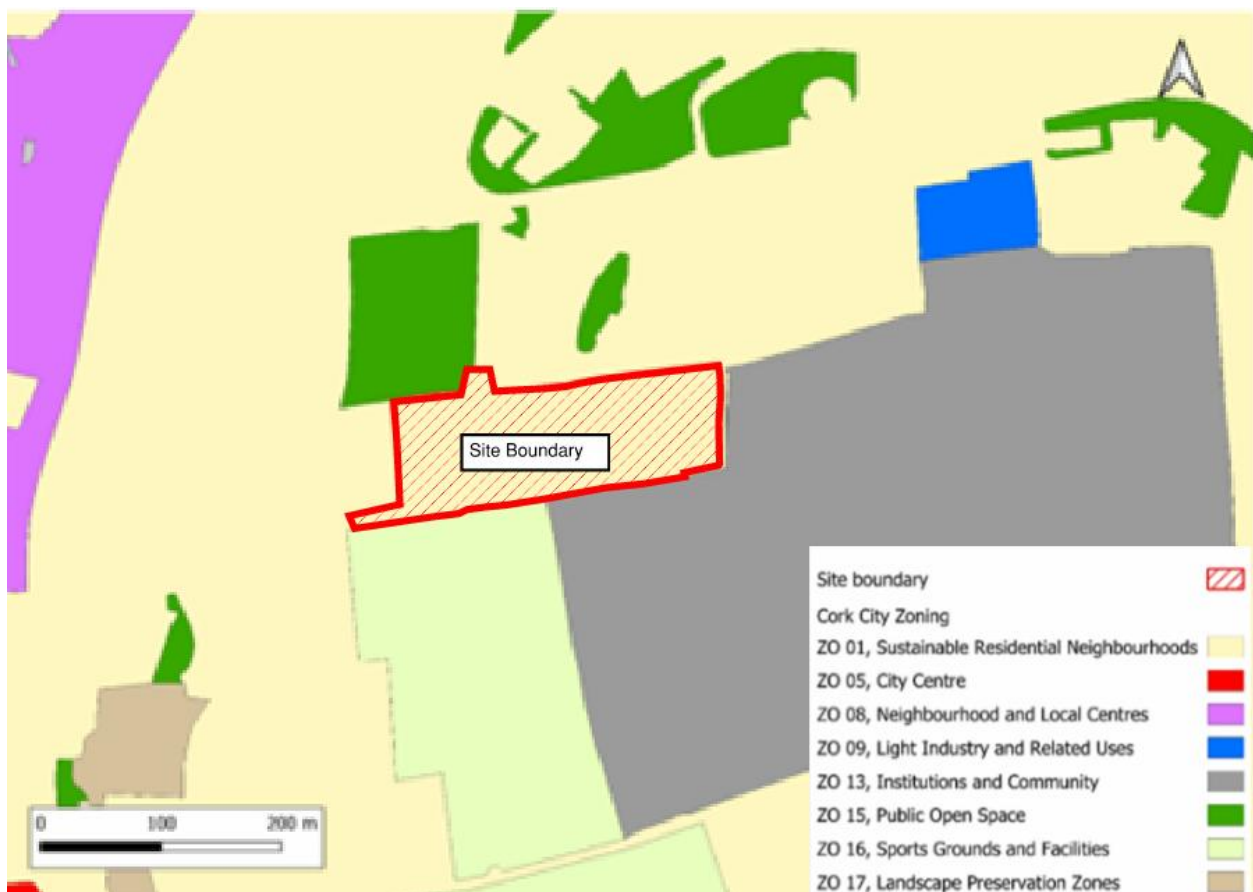
Figure 2-1 Subject Site Land Zoning

In the Cork City Development Plan, the land is zoned within ZO 01 ‘Sustainable Residential Neighbourhoods’, which its main objective is to protect and provide for residential uses and amenities, local services and community, institutional, educational and civic use. Refer to Figure 2-1 below:

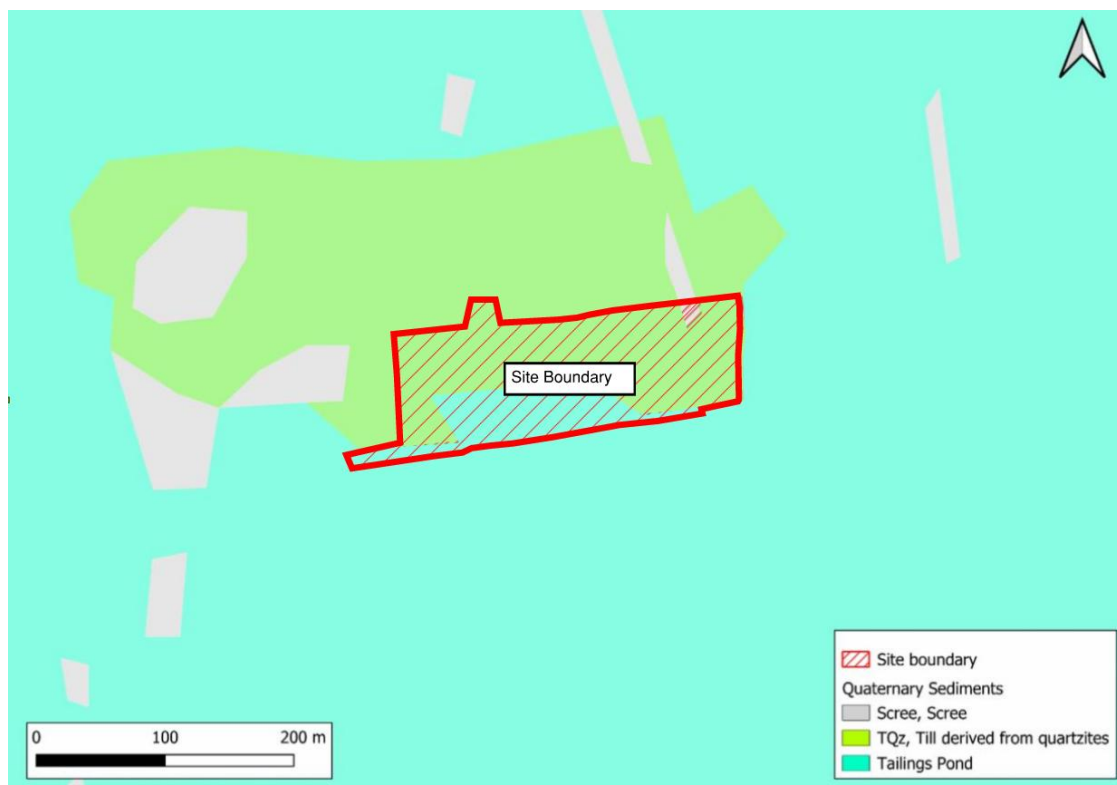
Figure 3-3: Subsoils around the Site (source Geological Survey of Ireland (www.gsi.ie))

The geology of the site was reviewed using data from the Geological Survey of Ireland (available at www.gsi.ie). The mapping indicates that the study area is underlain by three different quaternary sediment types

1. Tailing pond sediments to the south.
2. Scree (which is an assortment of broken rock fragments at the base of a steep rocky mass that has accumulated through periodic rockfall) which makes up the majority of the north of the site.
3. To the northeast there is till derived from quartzites, which is glacial sediment.

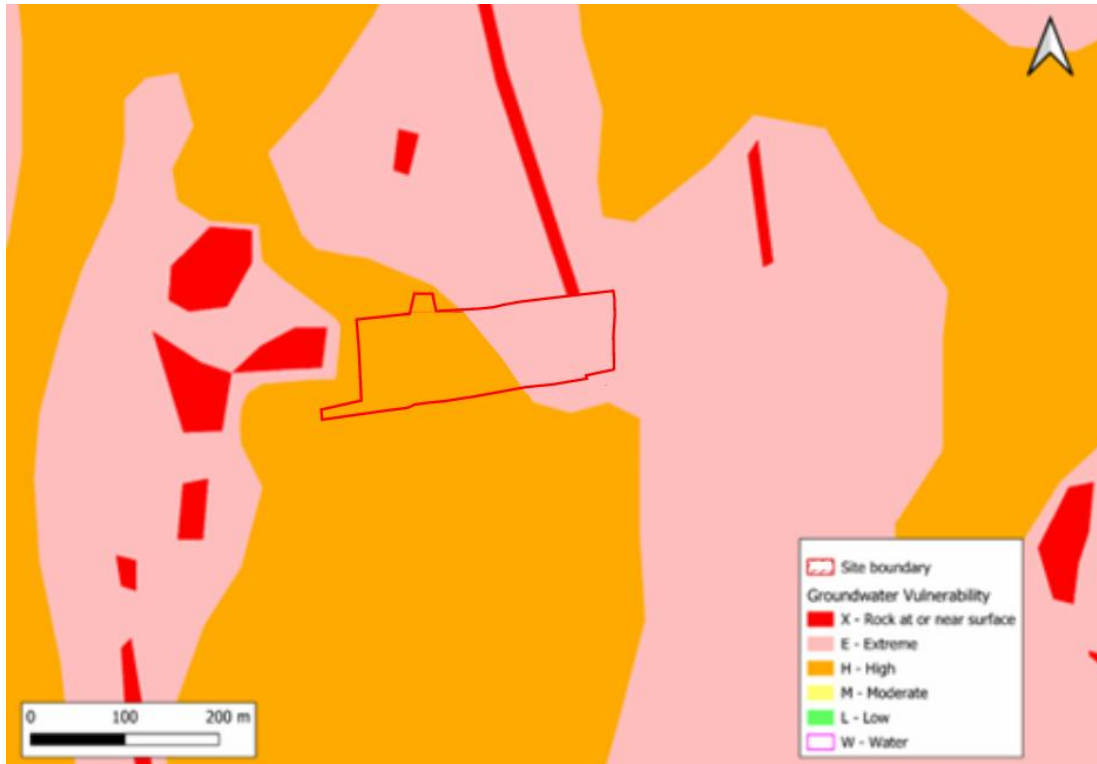
Figure 3-5 Groundwater Vulnerability Mapping (www.gsi.ie)

The site is also located in an area of 'High' to 'Extreme' vulnerability rating. The groundwater vulnerability rating is based on the predicted time for a pollutant released to the ground at the surface level to reach an aquifer level. Refer to Figure 3-5 below (ref: GSI).

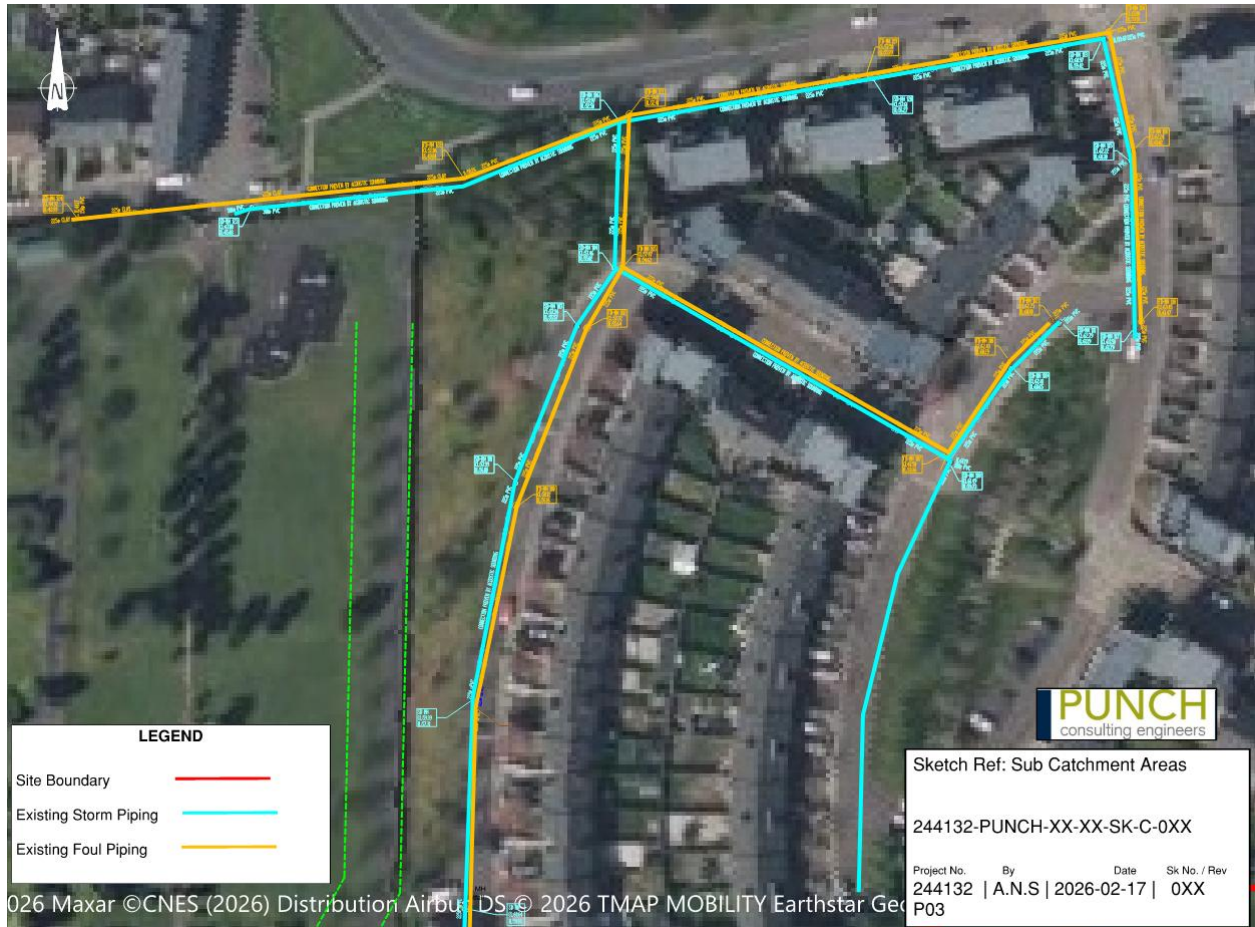
Figure 3-7 Existing Storm Drainage in Glentrasna Estate, to the north (extract from GPR survey)

There is however a surface water pipework within the Glentrasna Park area to the north of the site, which was picked up in a topographical / GPR survey with the manholes opened and inverts taken of the existing pipework to determine gradients. This network is suitable as a potential outfall for the proposed site. Refer to Figure 3-7 below for the GPR records in Glentrasna.

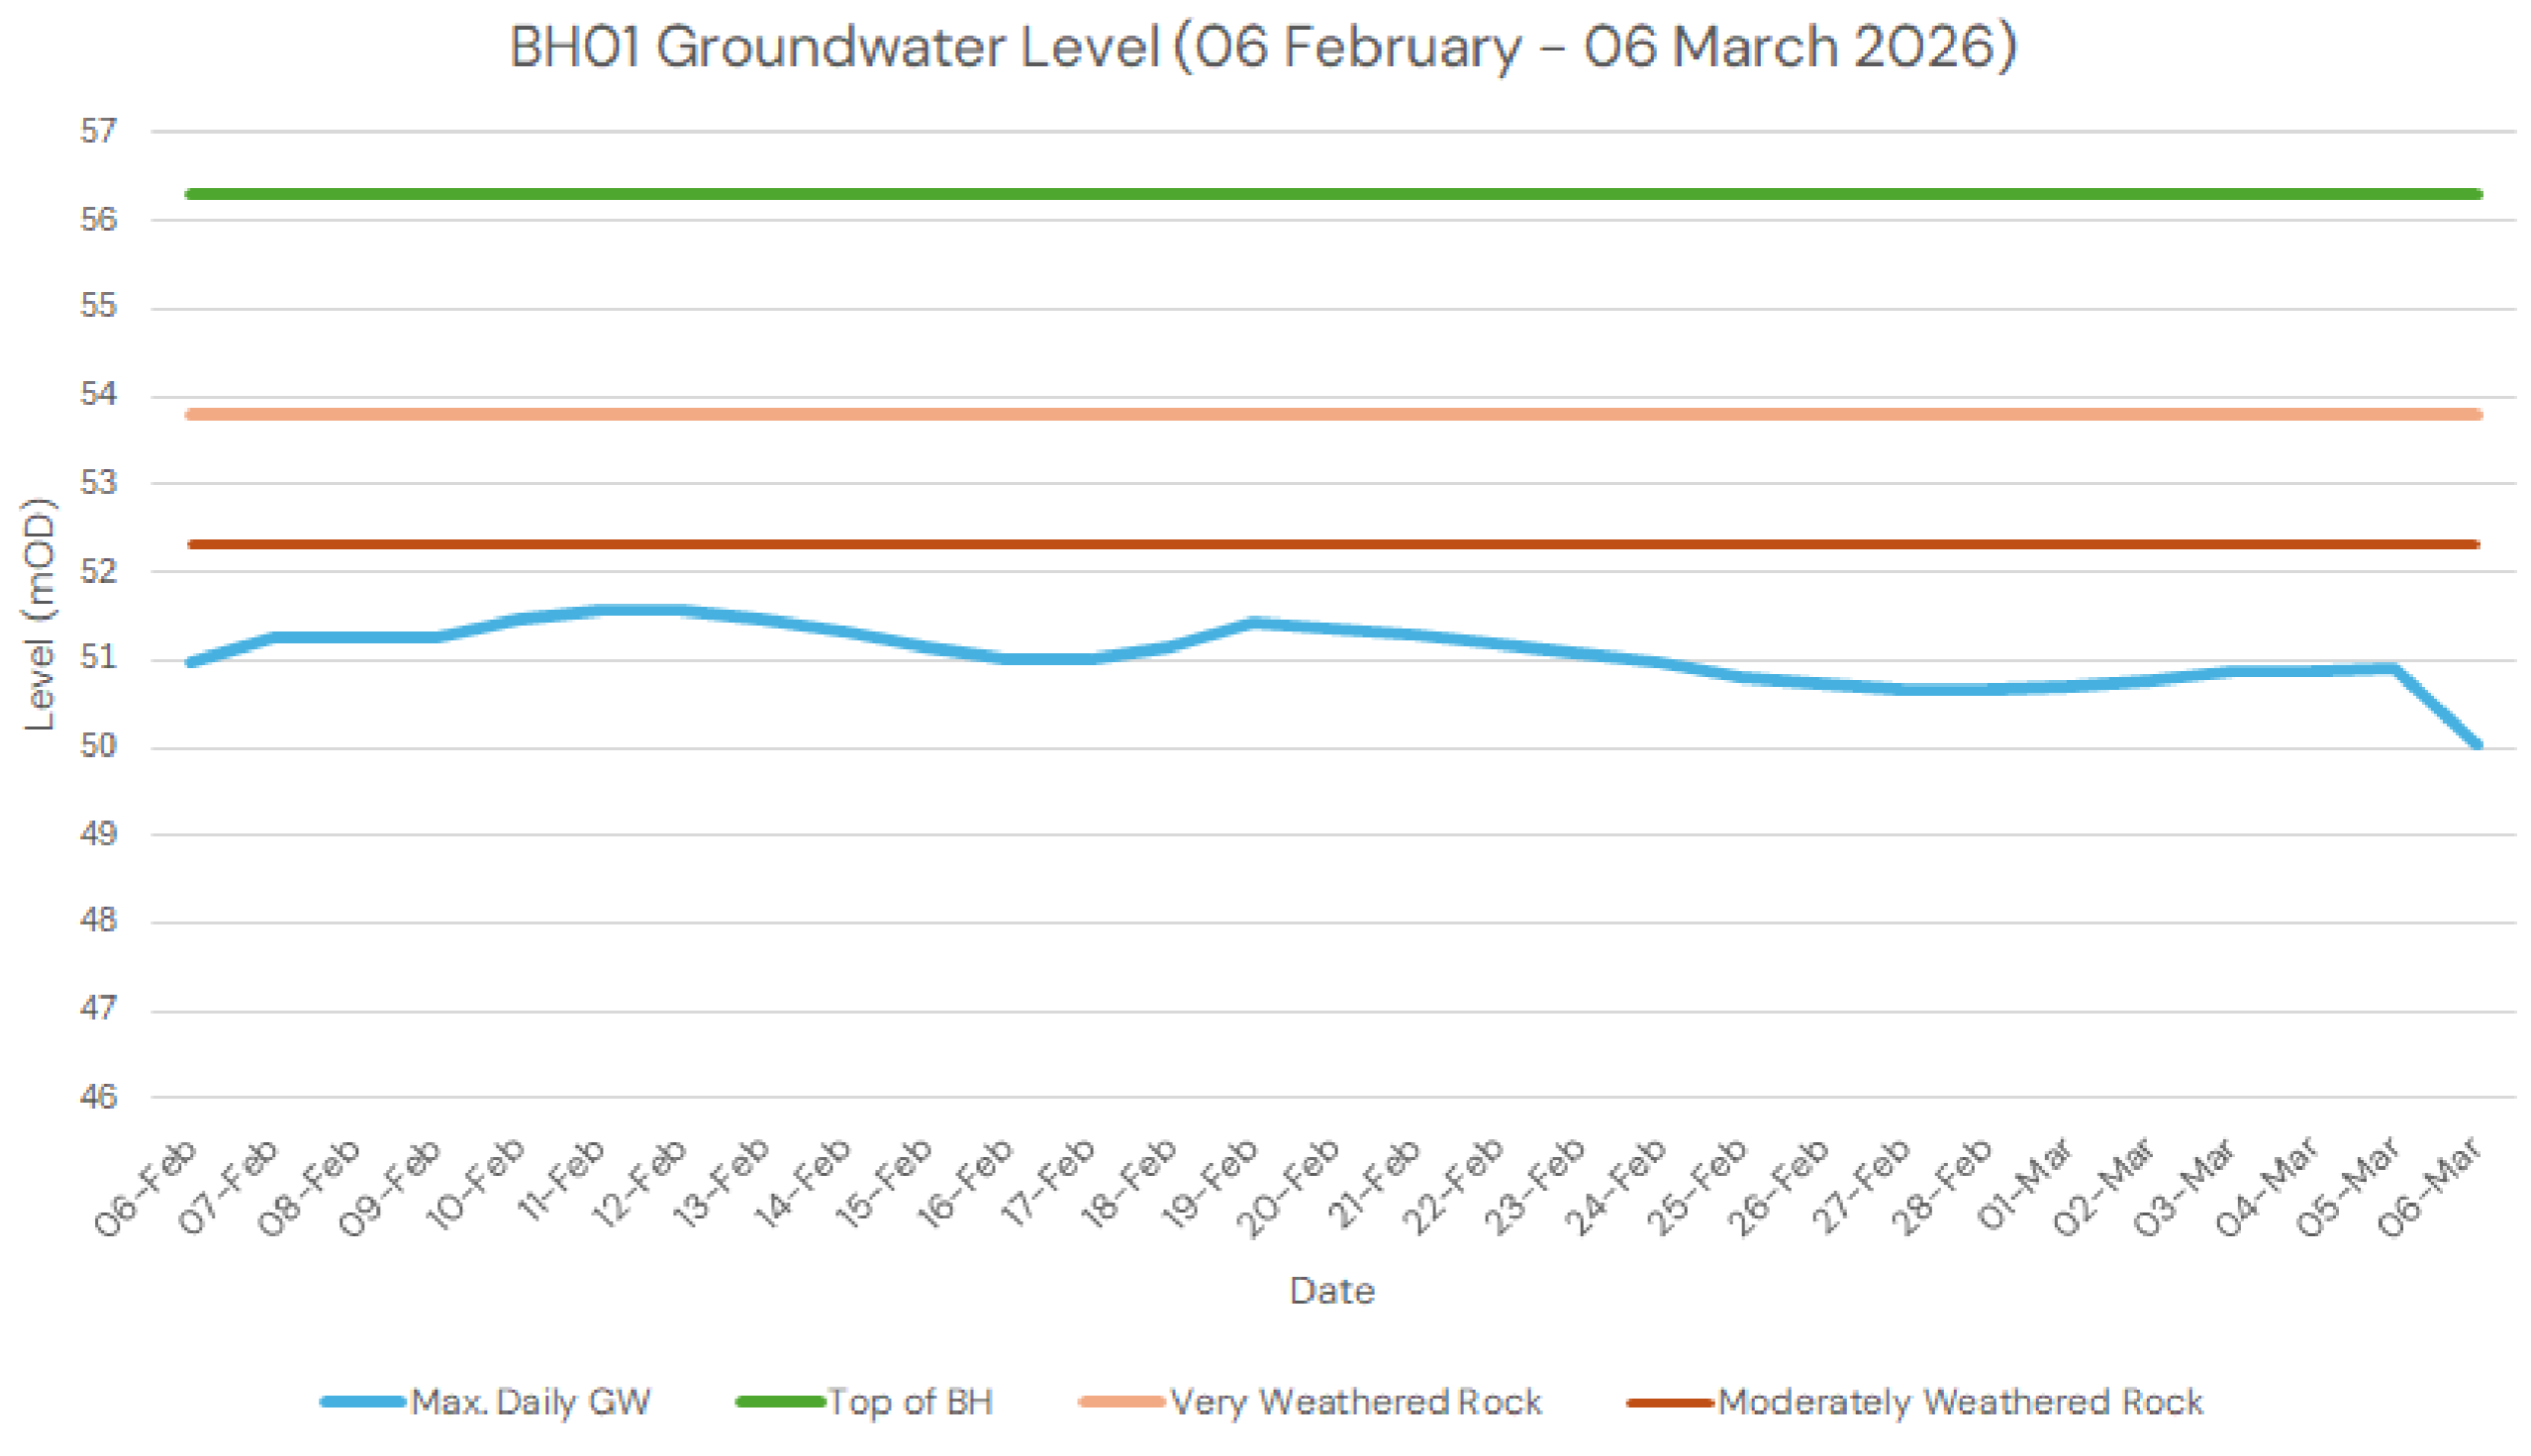
2026			
Months	Days	Max. Daily GW lvl (mOD)	
Feb	06-Feb	50.971	
	07-Feb	51.244	
	08-Feb	51.265	
	09-Feb	51.25	
	10-Feb	51.46	
	11-Feb	51.565	
	12-Feb	51.56	
	13-Feb	51.473	
	14-Feb	51.311	
	15-Feb	51.143	
	16-Feb	51.01	
	17-Feb	51.008	
	18-Feb	51.145	
	19-Feb	51.411	
	20-Feb	51.343	
	21-Feb	51.274	
	22-Feb	51.179	
	23-Feb	51.088	
	24-Feb	50.984	
	25-Feb	50.804	
	26-Feb	50.72	
	27-Feb	50.651	
	28-Feb	50.655	
	Mar	01-Mar	50.711
		02-Mar	50.758
		03-Mar	50.876
		04-Mar	50.885
		05-Mar	50.9
06-Mar		50.039

Top of BH	Very Weathered Rock	Moderately Weathered Rock
56.31 mOD	53.81 mOD	52.31 mOD

A summary of the groundwater measurements are shown for rotary boreholes BH01 & BH03 in the graphs included in Appendix A. The graphs also show the levels of the weathered bedrock. The measured ground water levels are at a higher elevation in BH03 which was carried out in the upper area of the site where the weathered bedrock is shallowest with the ground water levels slightly above the top of the weathered bedrock during the wet February 2026 measurements rising to a maximum of approx. 2.2m below ground level. The groundwater levels were reducing coming into March 2026 with the improvements in weather with levels dropping to approx. 3.75m below ground level. BH01 was carried out in the lower part of the site which shows the ground water levels within the weathered bedrock with less fluctuation in the readings through the February 2026 period with the ground water averaging at a level of approx. 5m below ground level in this rotary borehole. The standpipe readings in rotary borehole BH02 are similar with water levels at approx. 5.60m below ground level.

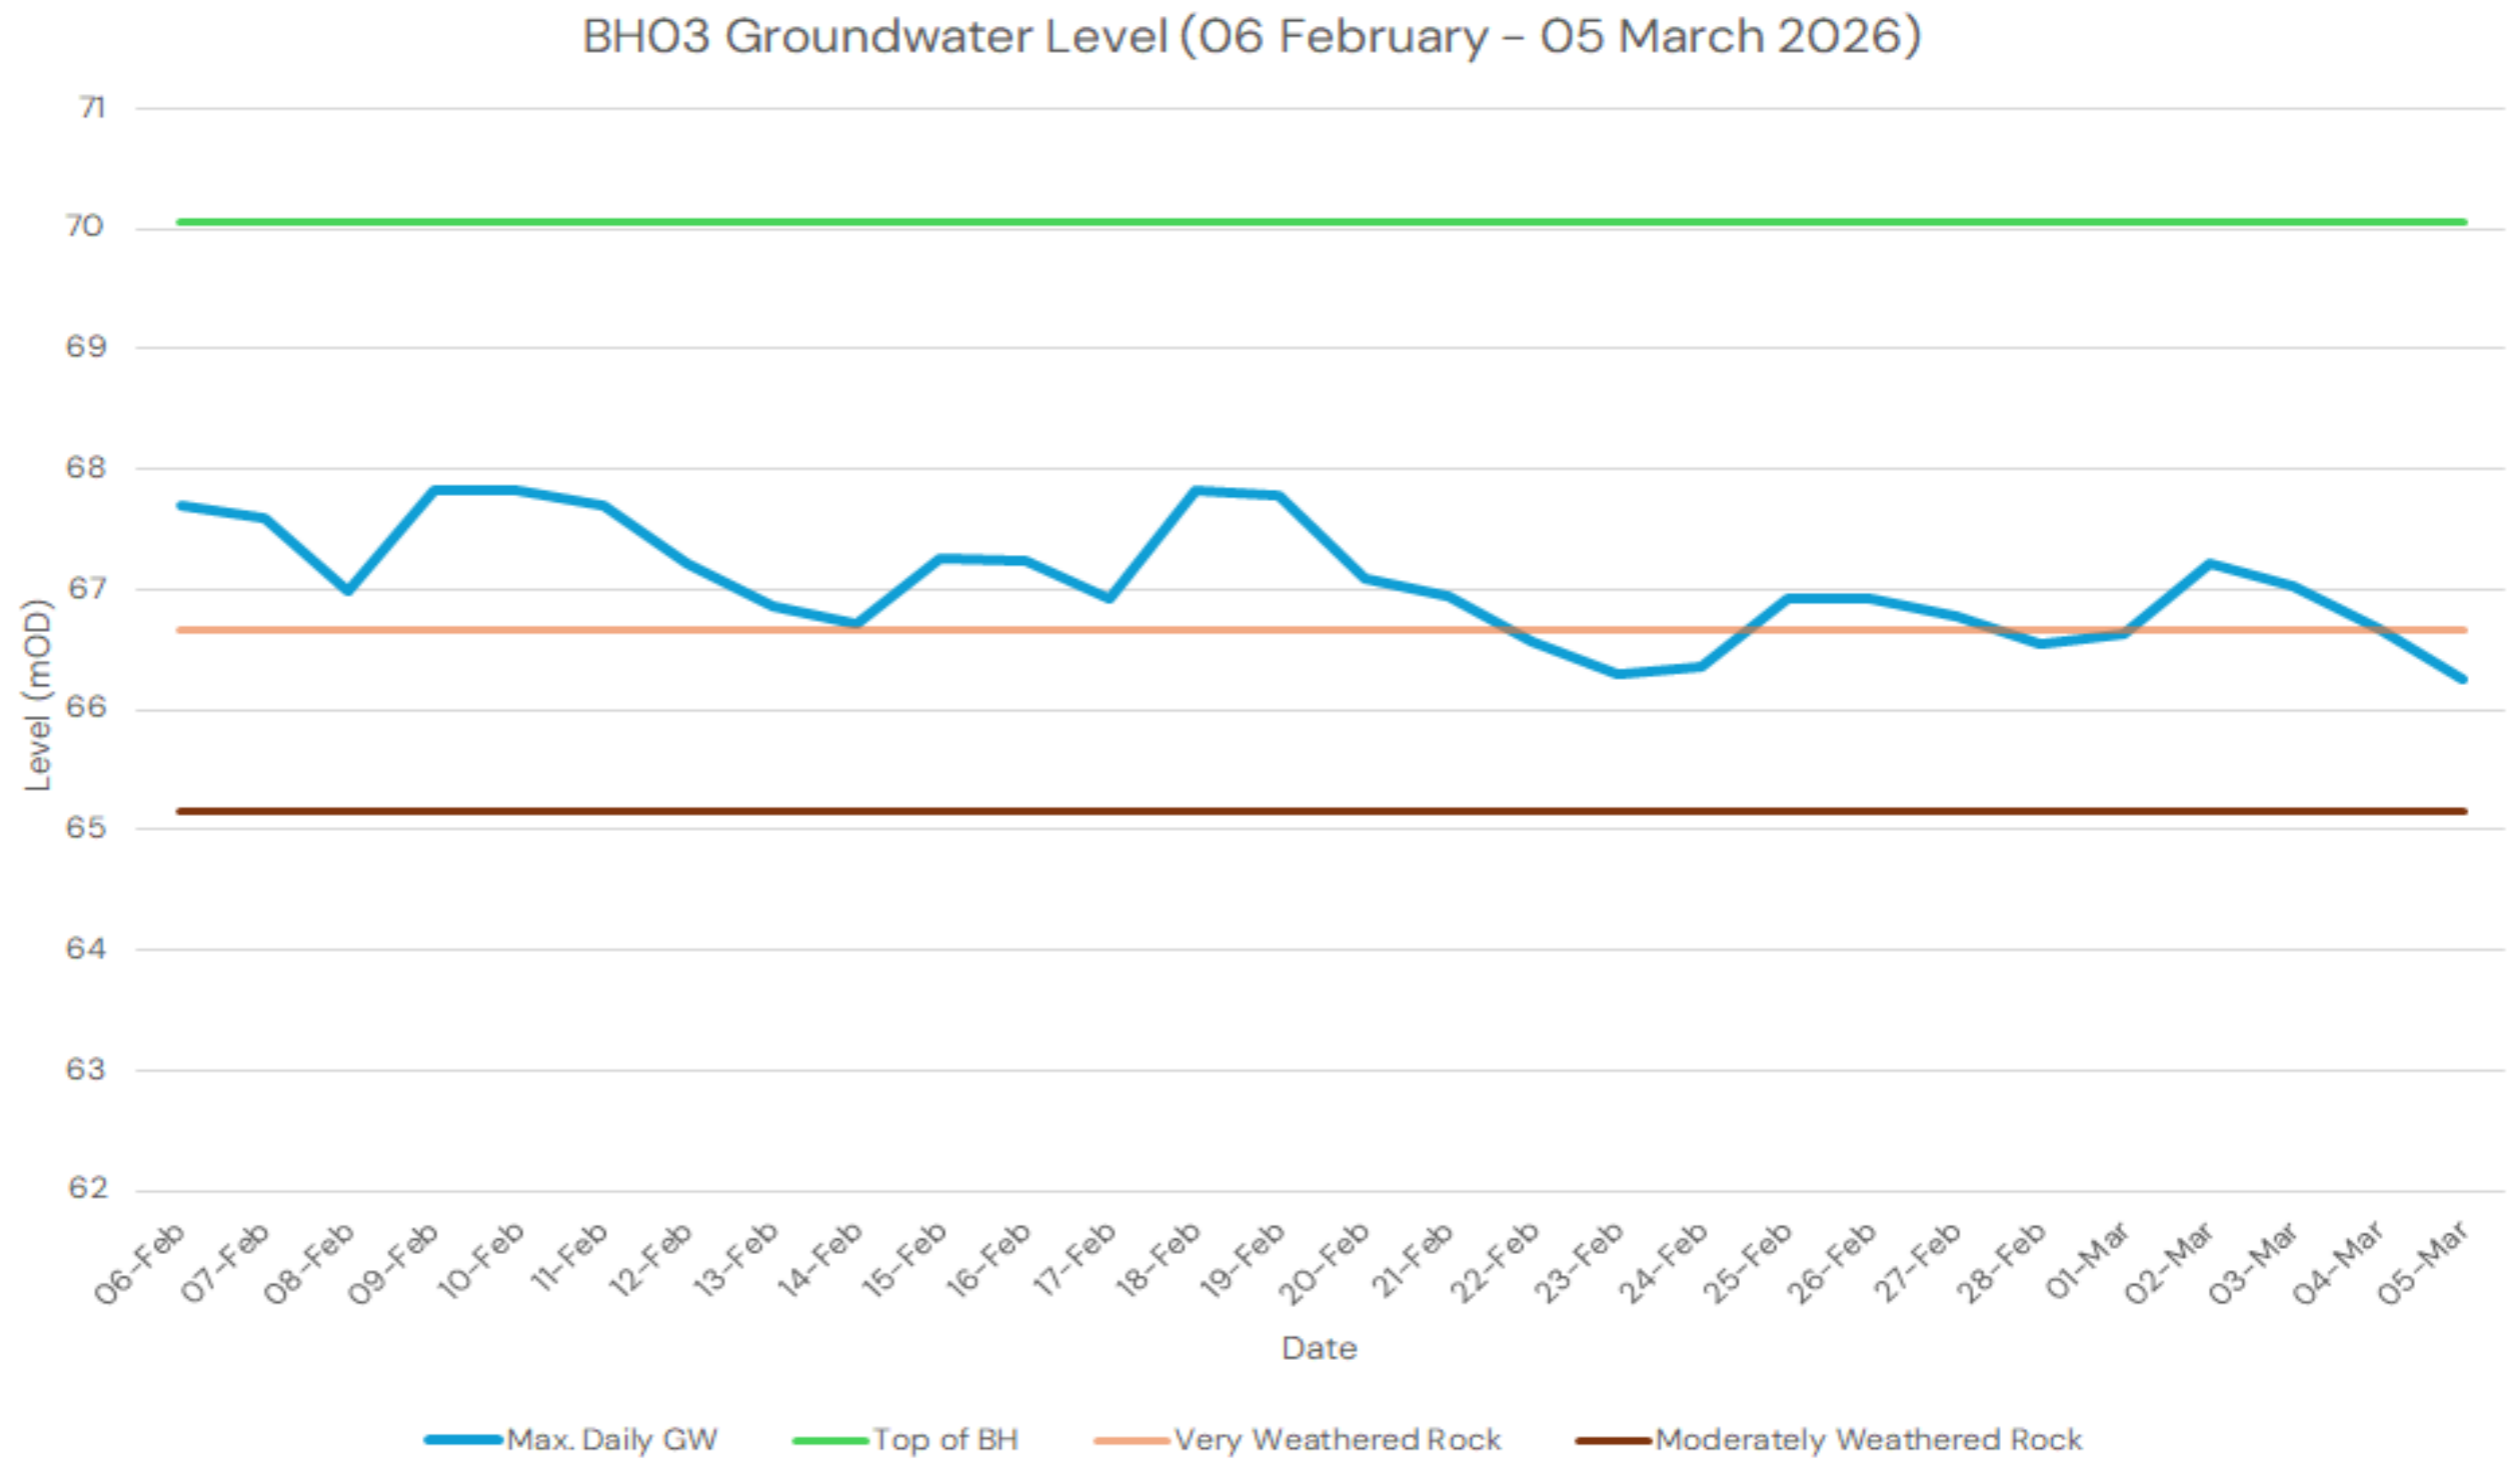
Months	Days	Max. Daily GW lvl (mOD)
Feb	06-Feb	67.6987
	07-Feb	67.5916
	08-Feb	66.9858
	09-Feb	67.82
	10-Feb	67.8211
	11-Feb	67.6917
	12-Feb	67.217
	13-Feb	66.8556
	14-Feb	66.7114
	15-Feb	67.2669
	16-Feb	67.227
	17-Feb	66.9151
	18-Feb	67.8225
	19-Feb	67.7921
	20-Feb	67.09
	21-Feb	66.9397
	22-Feb	66.5637
	23-Feb	66.3006
	24-Feb	66.353
	25-Feb	66.9176
	26-Feb	66.9186
	27-Feb	66.7844
	28-Feb	66.5515
Mar	01-Mar	66.6249
	02-Mar	67.2238
	03-Mar	67.0253
	04-Mar	66.6736
	05-Mar	66.2564

Level (mOD)		
Top of BH	Very Weathered Rock	Moderately Weathered Rock
70.06mOD	66.66mOD	65.16mOD
